Crews begin dismantling Longfellow Bridge ‘salt and pepper shakers’

By [Martine Powers](#) | GLOBE STAFF MARCH 08, 2014

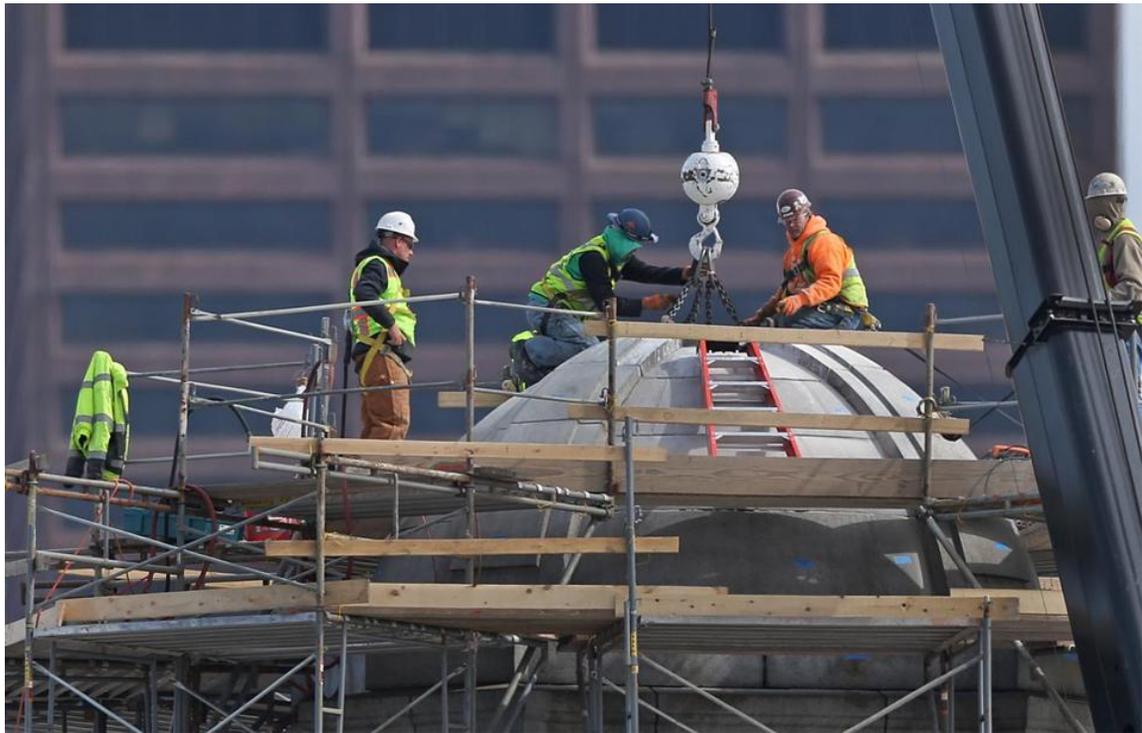
Workers (above) secured the cap of a bridge tower Friday before it was lifted off.

But over time, the granite blocks have settled, making the towers less stable. Crews will reconstruct them with stainless steel rods that will prevent them from shifting in the future. The blocks will also be cleaned, and any cracks or fractures will be repaired. As each is restored, they will be kept on wood pallets covered with plastic tarpaulins until the towers are ready to be reassembled later this year.

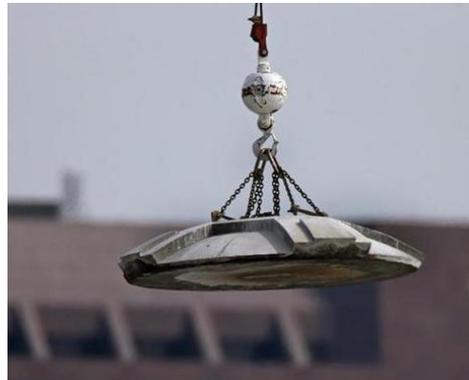
A large mounted crane lifted the cap from the tower.

Then they removed the very top of the tower — the salt dispenser, if you will — and used the crane to transfer it to the barge.
